# REPORT OF STABILITY ASSESSMENT OF ST. JOHN'S HIGH SCHOOL SECTOR-26 CHANDIGARH

National Institute of Technical Teachers Training & Research  
Sector-26, Chandigarh

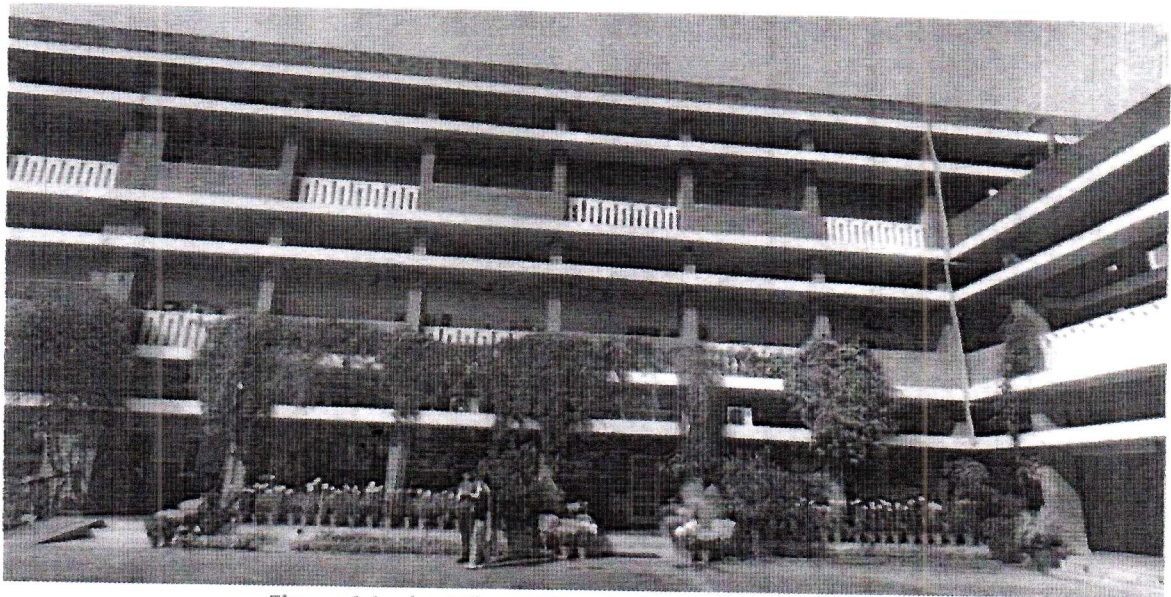
Figure 1 Junior Wing of St. John's High School

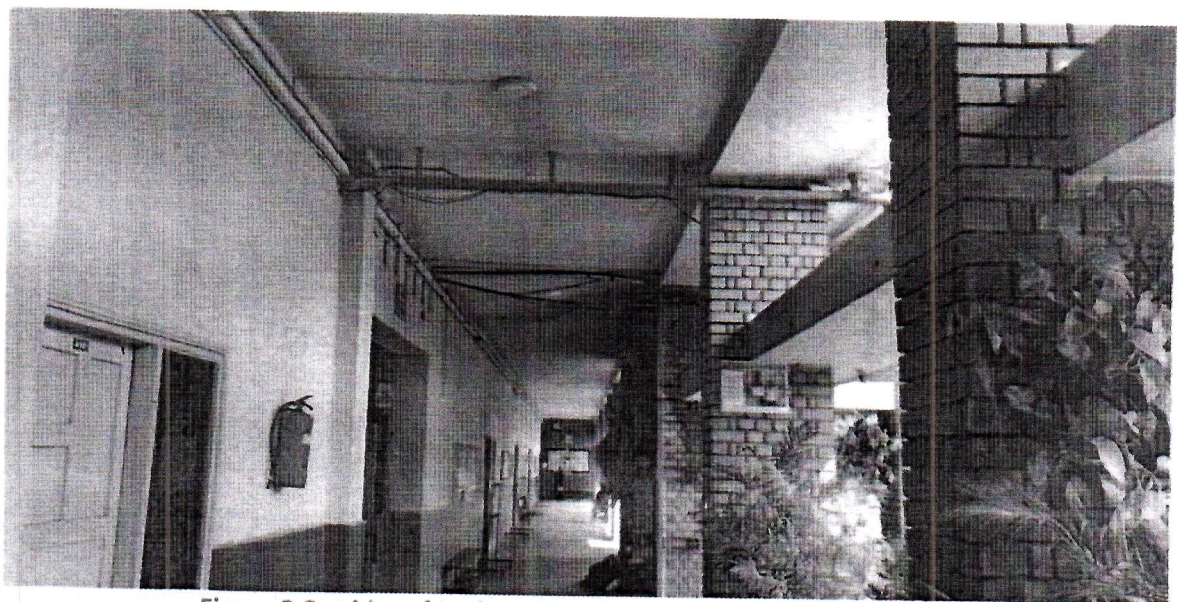
Figure 2 Corridor of Junior Wing of St. John's High School

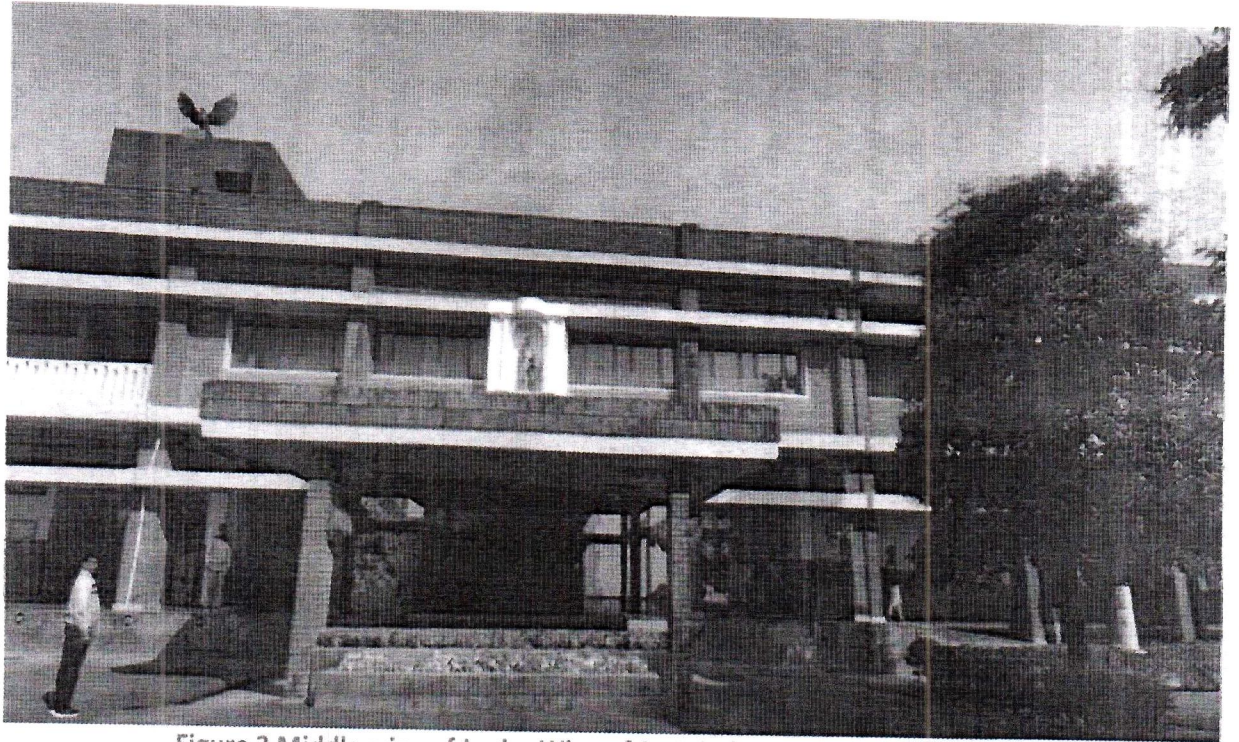
Figure 3 Middle wing of Junior Wing of St. John's High School

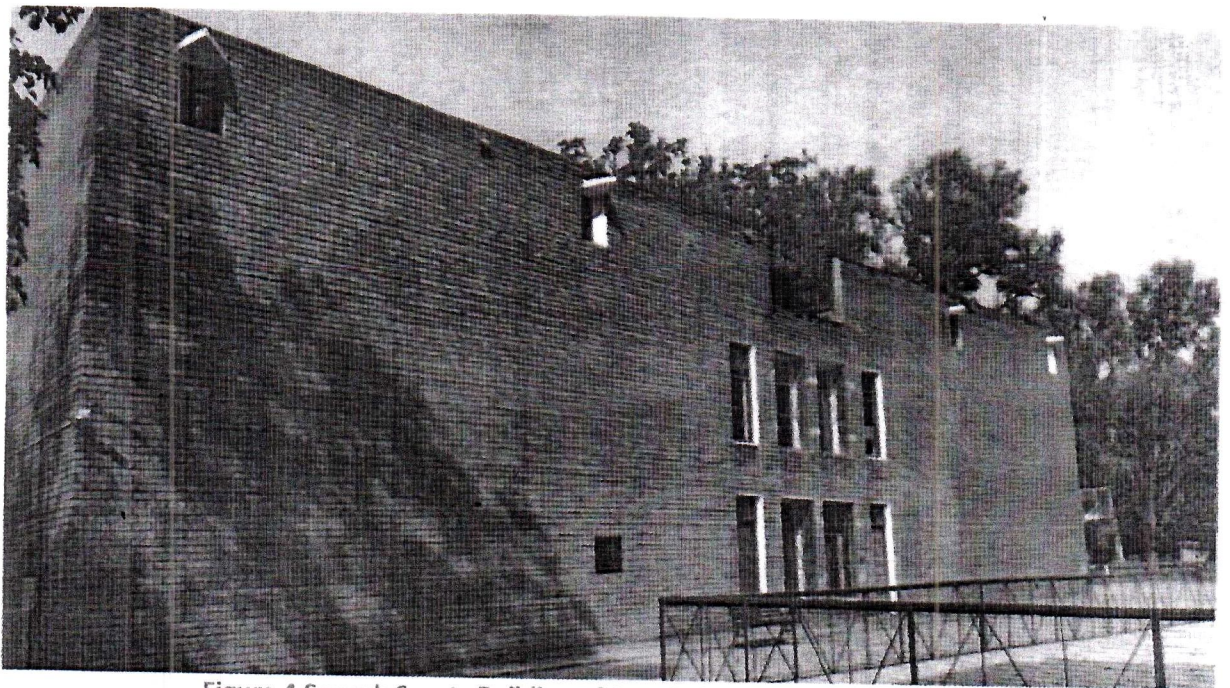
Figure 4 Squash Sports Building of St. John's High School

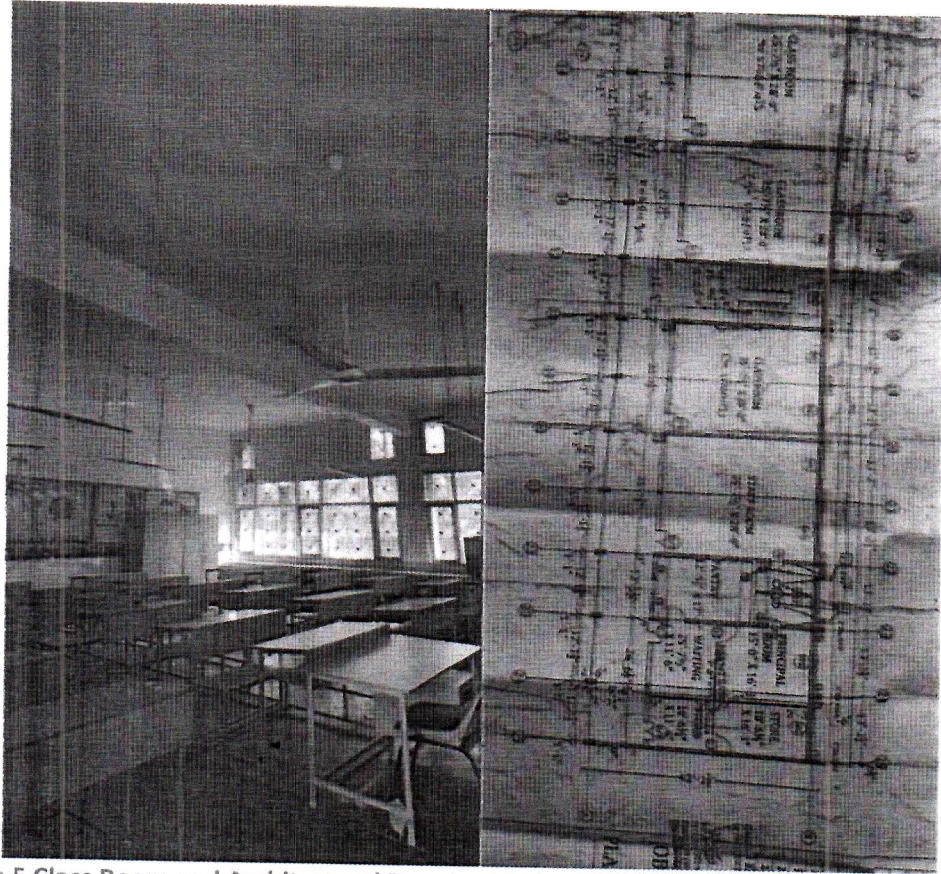
Figure 5 Class Room and Architectural Drawing Senior Wing of St. John's High School
